ASPECTS OF COMMUTATOR SKINS

TECHNICAL NOTE ■ STA BE 16-31 GB

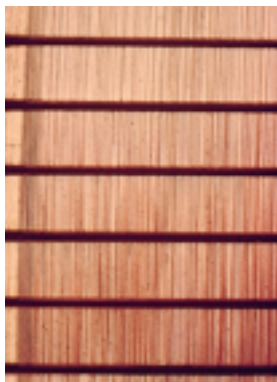
P 2

- P2 - P4 - P6: show normal skins.
Uniform, light maroon (P2) to darker maroon (P6).
The machine and brushes working well.

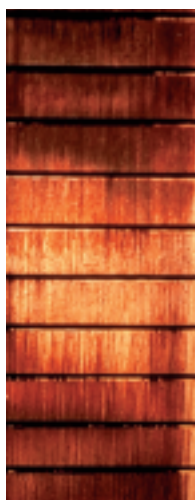
P 16

- P12: Streaky skin.
Lines and bands of varying size alternately light and darker without wear of the copper.
Most frequent cause: excessive humidity, oil vapours and aggressive gases in the atmosphere - under loaded brushes.
- P14: Raw grooved skin.
As P12, but with bands of the colour of raw copper or very slightly skinned. The metal is being attacked.
Most frequent causes: the same as for streaky skin but more intense or prolonged.
Also the brush grade may be unsuitable.
- P16: Patchy skin.
Of blotchy appearance having irregular and diverse colorations and dimensions without character of symmetry.
Most frequent causes: commutator deformed or dirty.

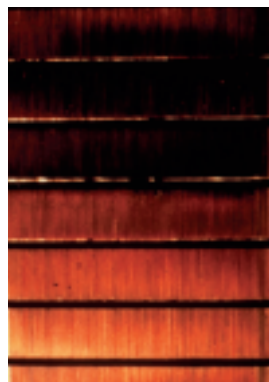
P 22

- P22: Isolated or regularly distributed blotches.
Dark blotches having blurred boundaries.
Most frequent causes: commutators out of truth (isolated blotch) or out of balance vibrations, defective bearings or alignment imperfect etc. (blotches regularly distributed in one or more zones of the commutator).
- P24: Dark blotches with sharp or irregular edges followed by lighter areas in alternating fashion with gradual reducing intensity of colour.
Most frequent causes: a fault affecting one bar or group of bars causing radial movement of the brush.
- P26 - P28: Bars marked at their centre or at their edges.
Shading at the centre of the bar or fringe marking at the edges.
Most frequent causes: defective maintenance of commutator, poorly turned or trued.

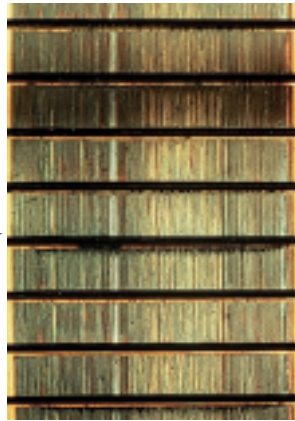
T 18

- T 18: Dark bar edge patches due to metallic fins at edge of bars.

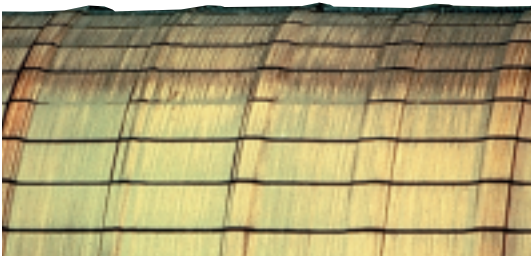
R 2

- R 2: Commutator with axial profile showing track growing with correct stagger. This wear may appear after a very long period of operation.

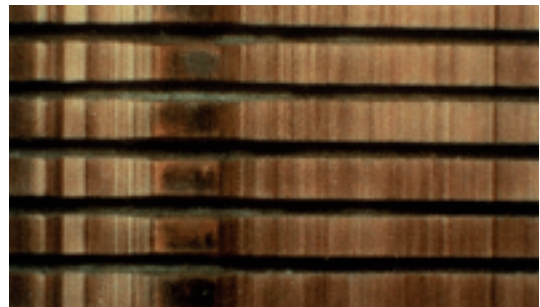
R 4

- R 4: Commutator showing abnormal wear of the metal through incorrect stagger, or grade unsuitable or various atmospheric pollutions.
